Browgill Stile Replacement

Birkwith

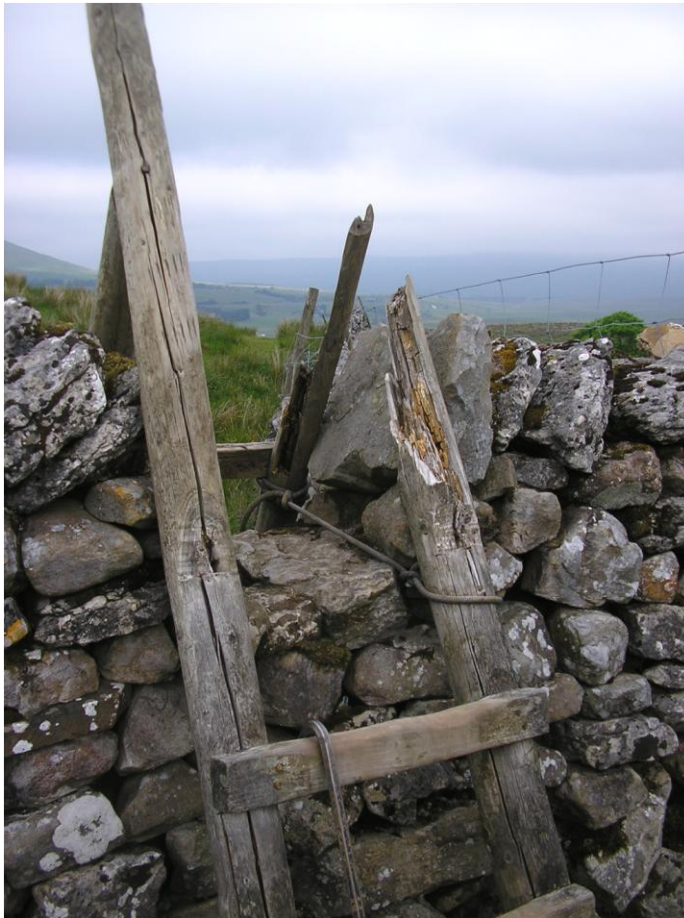
Cavers have been busy again improving the appearance of the countryside. Walkers on the Pennine Way past Calf Holes near Horton-in-Ribblesdale will have noticed the stile leading to Browgill Cave. Over the years it had deteriorated, steps had rotted away, and the main frame was being held together by a piece of old rope.
