## Red Moss Pot

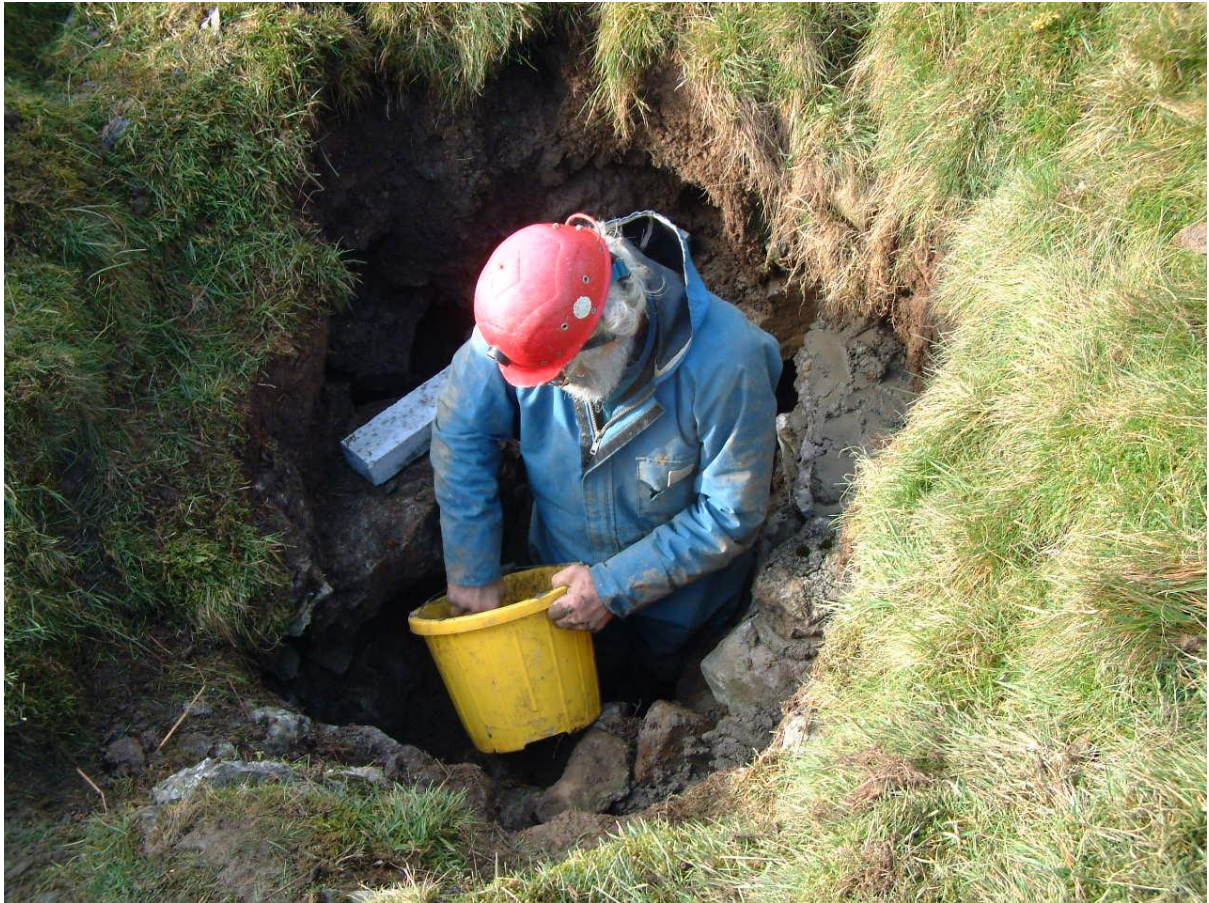
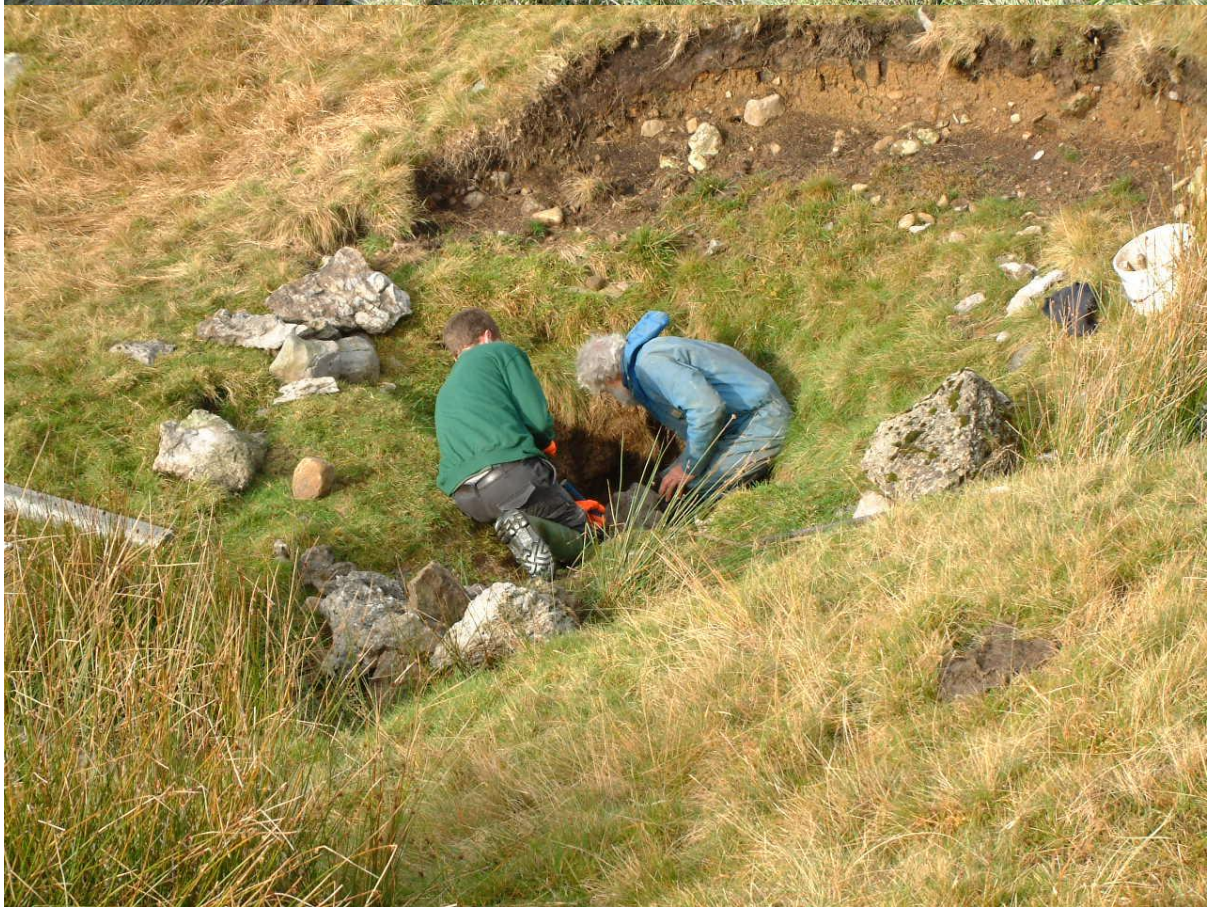
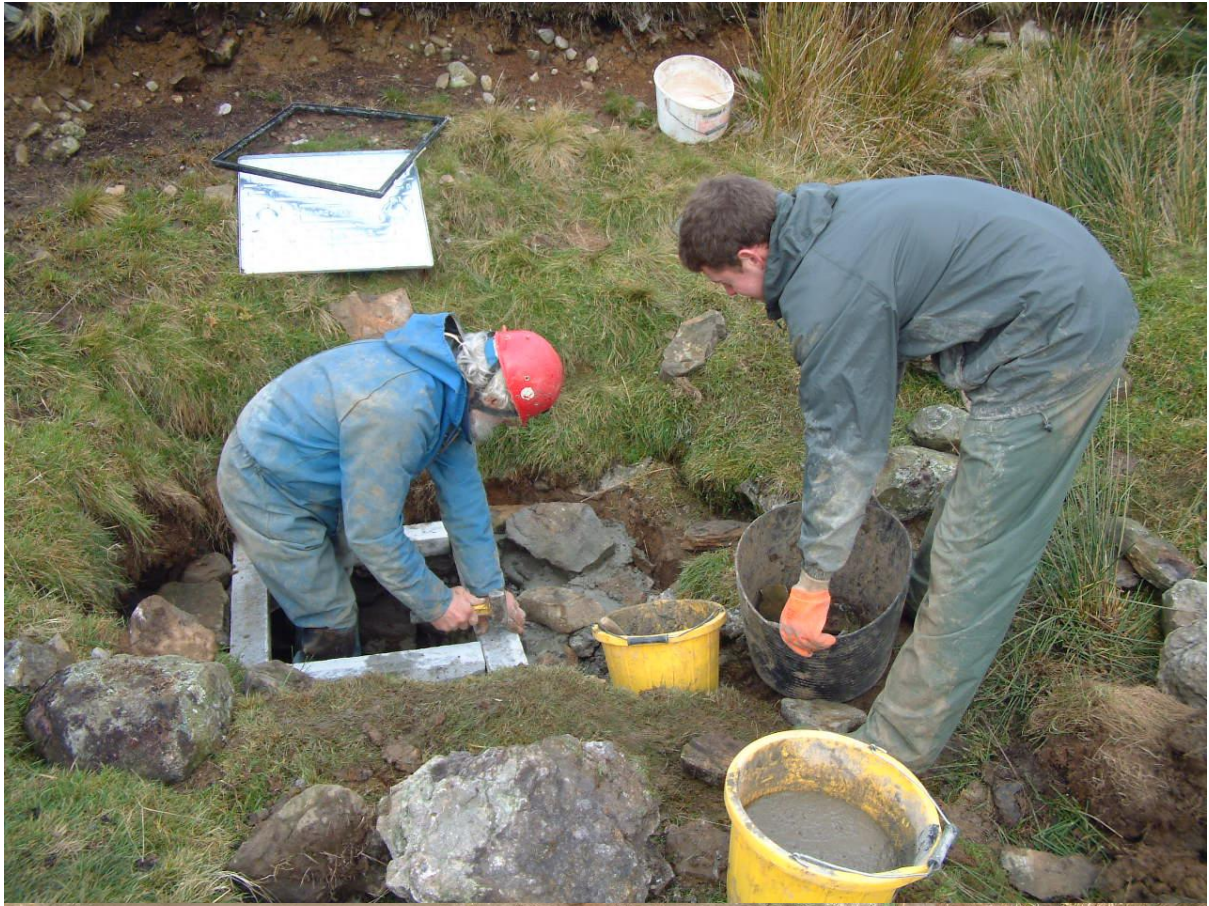
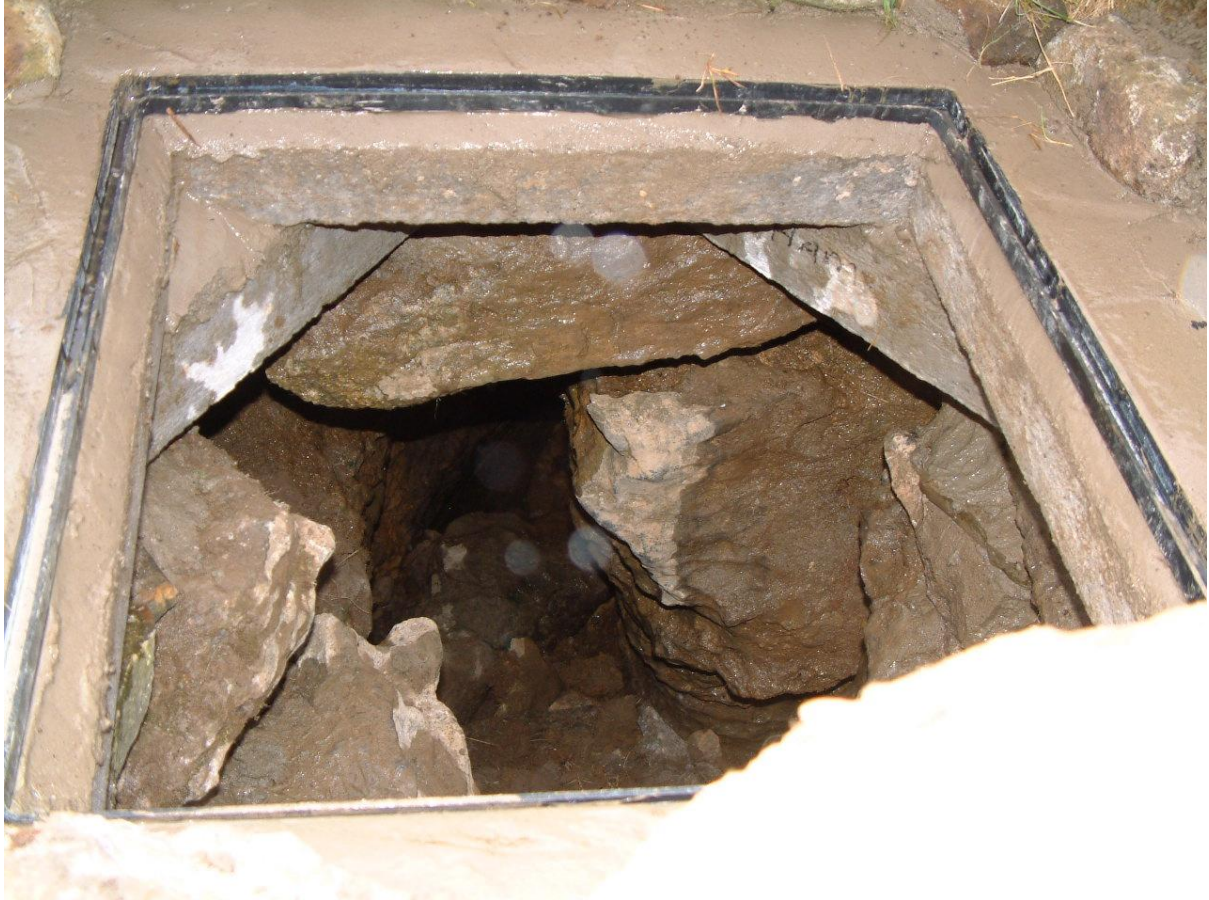
Pictures below show Jim Davis (contractor) and volunteer Tom Duckett making a tidy and imaginative solution to the problem of building across a rift entrance.

It was quickly agreed with the landowner that CNCC would make a stock proof lidded chamber over the entrance which would suit cavers and farmers needs. This work was carried out 10 days later by Jim Davis with a few CNCC volunteers. The farmer generously offered to take materials up to the site using his quad bike.

The work involved building a solid wall across the rift using light weight lintels and stone left over on site from a recent dry stone walling contract. The chamber was then capped with a 600mm square steel inspection cover. A small “letter box” slot was built into the side of the chamber to allow access for bats and natural airflow.
